INITIATION AND DISTRIBUTION OF FATIGUE CRACKS IN A FUSELAGE LAP JOINT CURVED PANEL

A. Ahmed¹, J. G. Bakuckas, Jr.², C. A. Bigelow², P. W. Tan², J. Awerbuch³, A. Lau³, and T. Tan³

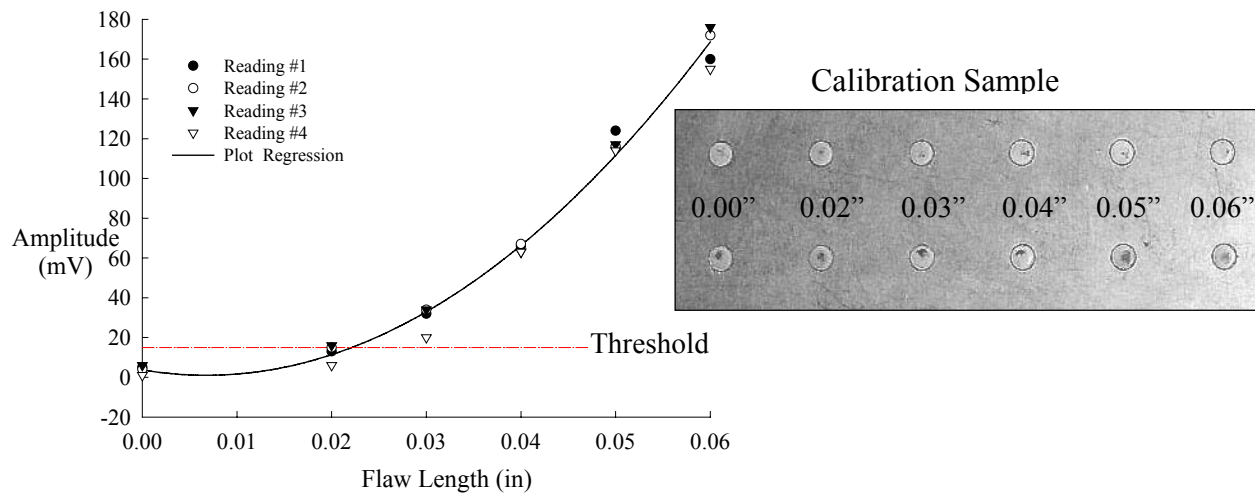
Figure 4. Calibration Plot for the Rotating Eddy-Current Probe System

Figure 4 shows the results of eddy-current inspections performed on a sample lap joint specimen that consists of two layers of 2024-T3 aluminum sheets fastened together by two rows of countersunk rivets. The rivet holes in the specimen contain either no damage or EDM notches ranging from 0.02" to 0.06".

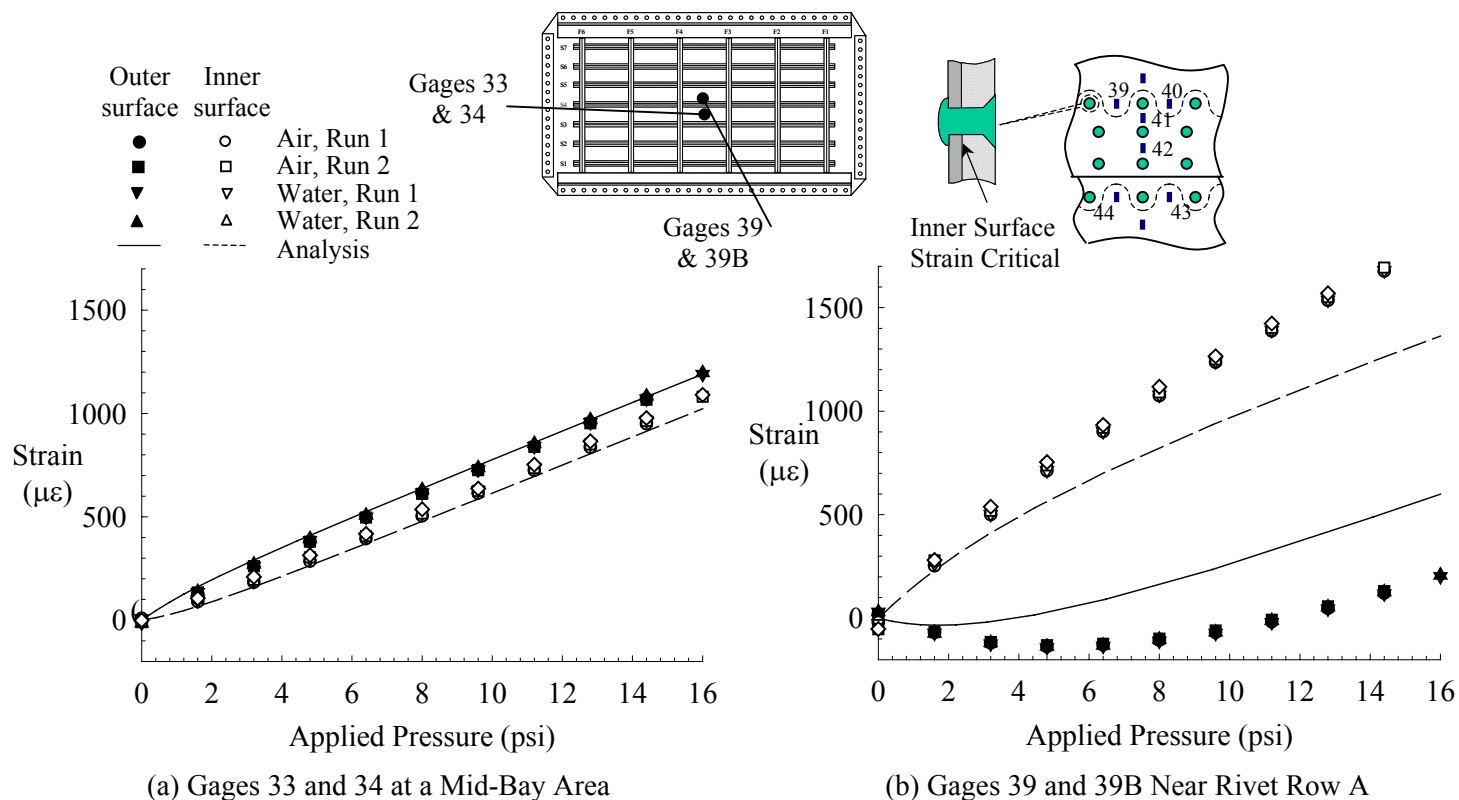
Figure 11. Comparison of Strains at Inner and Outer Skin Surfaces

Figure 11 shows the skin hoop strains from two sets of back-to-back gages, one located at a mid-bay area (gages 33 and 34) and the other at a lap joint area (gages 39 and 39B) near rivet row A. It can be seen that at the mid-bay area the strain on the outer surface is slightly higher than that

on the inner surface, indicating that the skin is primarily under in-plane loading with relatively minor bending effect. This is also verified quite accurately by the results of the finite element analysis. In the lap joint area near rivet row A, however, the strain on the inner skin surface is seen to be several orders of magnitude higher than that on the outer skin surface, revealing the existence of a significant bending effect in that area. This local bending effect is a result of the eccentricity due to the lap joint geometry and explains why cracks normally initiate at the inner skin surface at the rivet hole and propagate outward. The analysis results are in reasonable agreement with the experimental results.

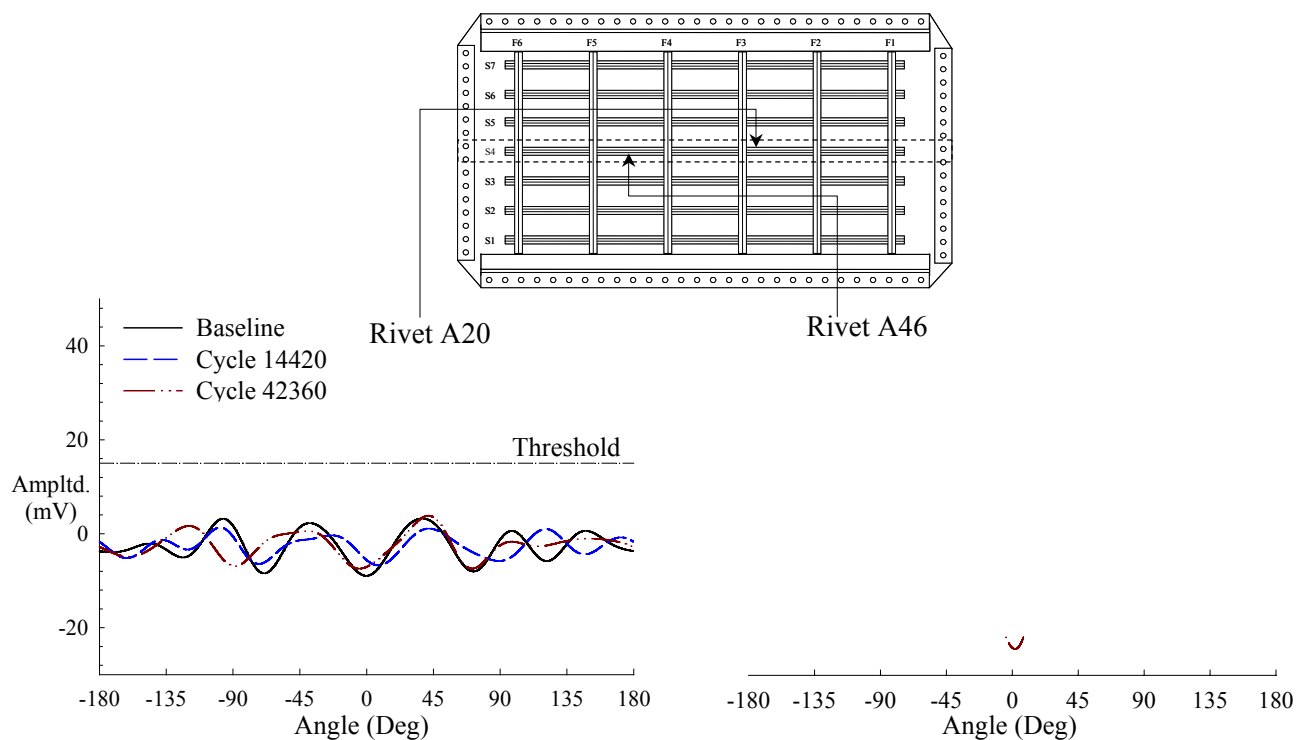
(a) Eddy-Current Inspection Results for Rivet A20 (b) Eddy-Current Inspection Results for Rivet A46
Figure 12. Sample Eddy-Current Results

Figure 12 shows the eddy-current inspection results from two rivets, located along the critical rivet row A, at various stages of the fatigue test. The signal levels from rivet A20, shown in Figure 12a, are seen to remain more or less constant up to 42,360 fatigue cycles and are much lower than that of the system's threshold. Of the 345 rivets that are being inspected with the rotating probe system, all but seven lap joint rivets are showing similar low levels of eddy-current signals, indicating that no cracks have been initiated from those rivet holes.

Figure 12b shows the eddy-current signals of rivet A46, one of the seven rivets that exhibit changing signal levels. Even though the signal levels have exceeded the system's threshold only slightly, the fact that the signal level has been increasing with the increasing fatigue cycles may indicate the existence of a growing hidden fatigue crack at that location. No visible damage has yet been detected, but these seven rivets are being closely monitored with the RCCM system.
